IV. RESULTS

HISTORIC ARCHITECTURE

URS Corporation identified and evaluated 14 historic properties within the project's historic architecture APE that are more than 50 years in age (Figure 4.1):

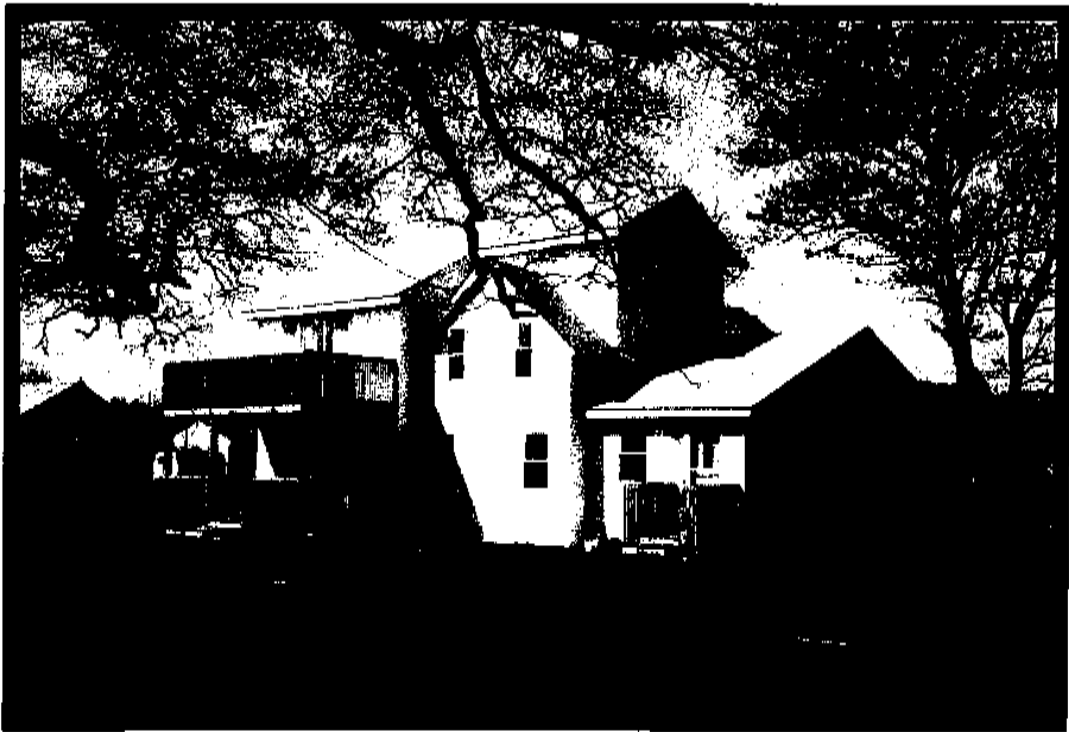
Plate 4.1 Dwelling (S-10037), View Southwest of Front and Side Façades.

This property contains a two-story dwelling, originally built circa 1870, and a frame garage built circa 1960 (Plates 4.1 and 4.2). The dwelling, as presently constructed, is in good condition and is located close to Burbage Road (Road 353) on a 1.51-acre parcel in a semi-rural setting. The historic context for this resource is "Architecture in the Lower Peninsula/Cypress Swamp Zone, 1830-1880 +/-." The resource exhibits no association with farming and therefore is not representative of a historic context for agriculture.

The dwelling on this property has been completely remodeled in the last five years. The original house is the middle two-pile, two-story section. Modern additions are attached to the front, rear, and roof. The original house is frame construction on a concrete block foundation. The exterior walls are finished with vinyl siding. The gable roofs are covered with asphalt shingles. The original house has rectilinear windows with vinyl replacement, one-over-one, double-hung sash. The additions have modern rectilinear and half-round windows with fixed and double-hung sash. A modern frame flue is attached to a rear corner. Modern wood decks are attached to the front

and rear additions. The garage is frame construction with vinyl siding on the exterior walls and a front-gable roof covered with standing seam metal.

This property lacks the necessary physical integrity to be eligible for listing in the NRHP. Key character-defining features have been obscured or replaced, including the original wood siding and wood windows. Additionally, large additions to the front and rear façades have interrupted the historic massing and scale of the resource.

Because its integrity has been compromised, this property lacks important character-defining features of a massed-plan, side-gable house, as defined in the research design. The building's original wood siding and windows have been replaced by vinyl siding and vinyl windows, respectively. The use of wood is defined as an important, character-defining feature in this property type. In addition, the building's original massing has been compromised by additions. As such, this building lacks critical character-defining features associated with its property type. Thus, this property is not considered eligible for listing under Criterion C.

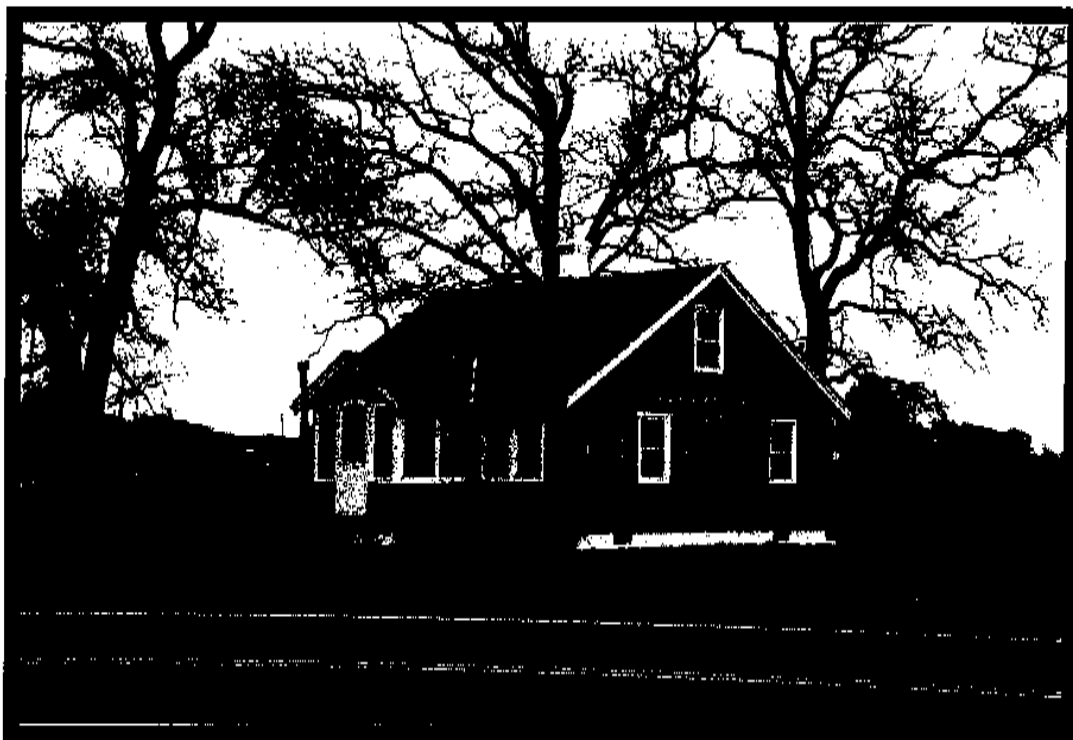
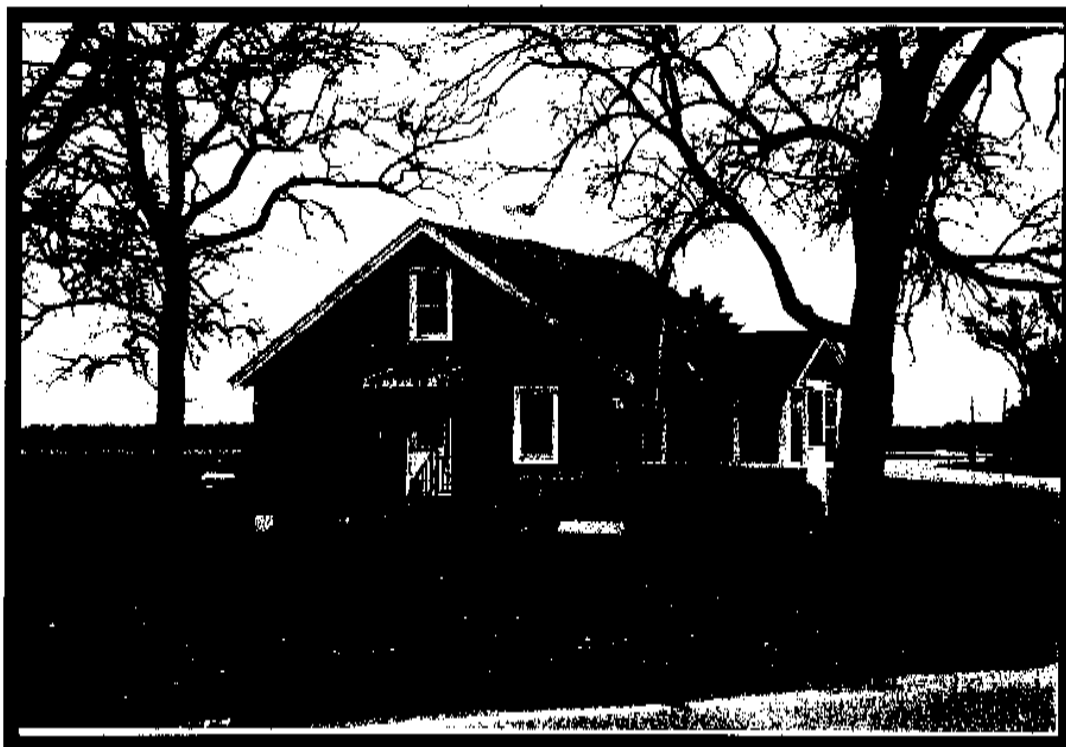
Plate 4.3 Clinton Robinson House (S-10030), View East of Front and Side Façades.

This property contains a one-and-one-half-story dwelling, built circa 1945, with bungalow-style details (Plates 4.3 and 4.4). The dwelling is in good condition and is located on a 0.23-acre parcel at the southeast corner of Roxanna Road (State Route 17) and Burbage Road (Road 353). Its setting is semi-rural; a farm field is located south and east of the dwelling and a modern storage facility is located on the opposite side of Roxanna Road. The historic context for this resource is "Architecture in the Lower Peninsula/Cypress Swamp Zone, 1940–1960 +/-."

The house is frame construction built on a concrete block foundation. The exterior walls are finished with asbestos siding. The gable roof has exposed rafter ends and is covered with asphalt shingles. A painted brick chimney projects from the middle of the rear slope at the ridge. Windows are rectilinear with original, six-over-one, double-hung wood sash. The front entrance is accentuated with a projecting front-gable enclosed porch. There is a small metal-canopied

porch on the side elevation covering the secondary entrance. A small, frame utility enclosure addition is under construction on the rear elevation.

Visual inspection does not indicate that the Clinton Robinson House is significant for its distinctive characteristics or method of construction. This resource is a mid-twentieth-century vernacular bungalow (concrete block foundation, asbestos shingle siding) that lacks the hallmarks of a high-style, architect-designed, or even mail-order version of the type. As noted in the research design, this resource lacks a verandah, as well as the interpenetration of inner and outer space, that are defining characteristics of a bungalow. Regarding Herman's findings on "rural bungalows," this resource lacks a broad porch, low-pitched roof, and shingle or clapboard siding that Herman identified as defining characteristics of this type. Thus, this property is not considered eligible for listing under Criterion C.

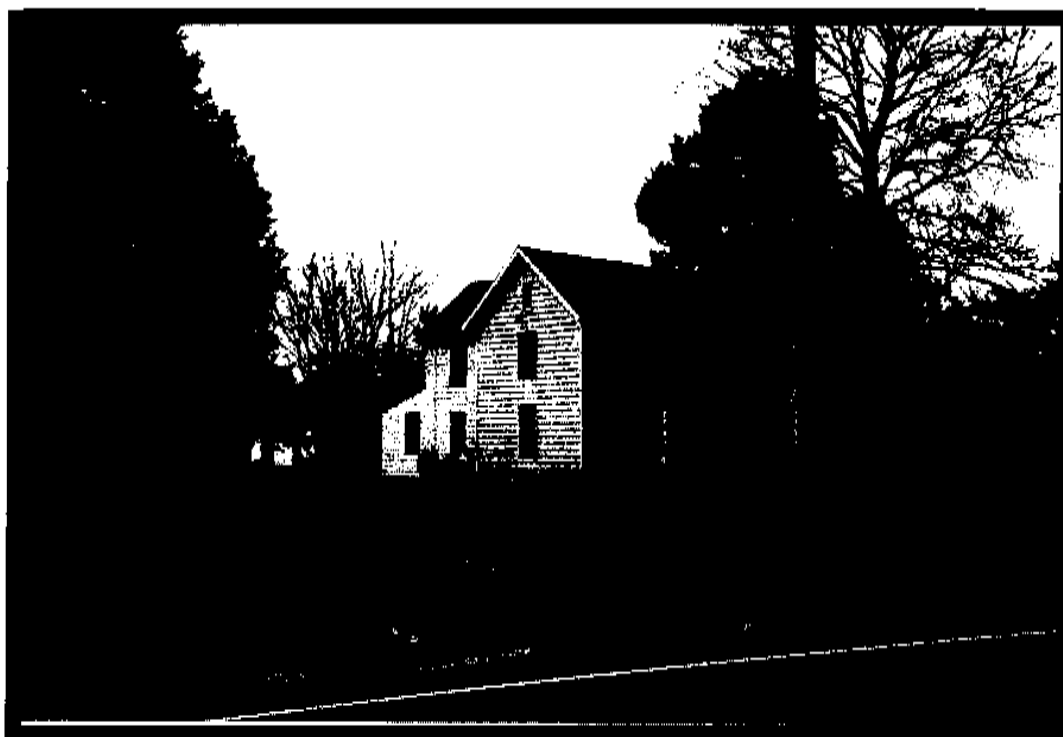
Plate 4.5 John R. Townsend House (S-2455), View Northeast of Front Façade.

This property contains a two-and-one-half-story dwelling, built circa 1875, and a garage, built circa 1925 (Plates 4.5 and 4.6). The dwelling is in good condition and is located on a 6.51-acre parcel in a semi-rural setting. The historic context for this resource is "Architecture in the Lower Peninsula/Cypress Swamp Zone, 1830–1880 +/-." The resource exhibits no association with farming and therefore is not representative of a historic context for agriculture.

The original dwelling is the three-bay, single-pile I-house. The two-and-one-half-story addition to the rear, forming the T-shaped plan, may be original or an early addition. Mid-twentieth-century one-story additions are attached to the south and rear elevations. The house is frame construction built on a modern concrete block foundation. The exterior walls are finished with vinyl siding. There are gable roofs over the two-and-one-half-story sections and shed roofs over the one-story additions. All roofs are covered with asphalt shingles. The windows are rectilinear with original one-over-one, double-hung sash—the exceptions are a fixed window on the addition and attic windows with jalousie sash. The screen porch centered on the front façade has vinyl sided-base walls and grillework detailing. The rear elevation has a door with jalousie sash. The garage is frame construction with clapboard walls and a pyramidal roof covered with asphalt shingles.

This property lacks the necessary physical integrity to be eligible for listing in the NRHP. Key character-defining features, such as original wood siding, have been obscured or replaced. Further, additions to the rear façade, albeit minor, have modified the historic massing and scale of the resource.

Because its integrity has been compromised, this property lacks important character-defining features of an I-house, as defined in the research design. The building's original wood siding has been replaced with or obscured by vinyl siding. The use of wood is defined as an important, character-defining feature in this property type. Also, the concrete block foundation presents a material that is incongruous with a nineteenth-century I-house. Lastly, the building's original massing has been slightly compromised by additions to the rear façade. As such, this building lacks critical character-defining features associated with its property type. Thus, this property is not considered eligible for listing under Criterion C.

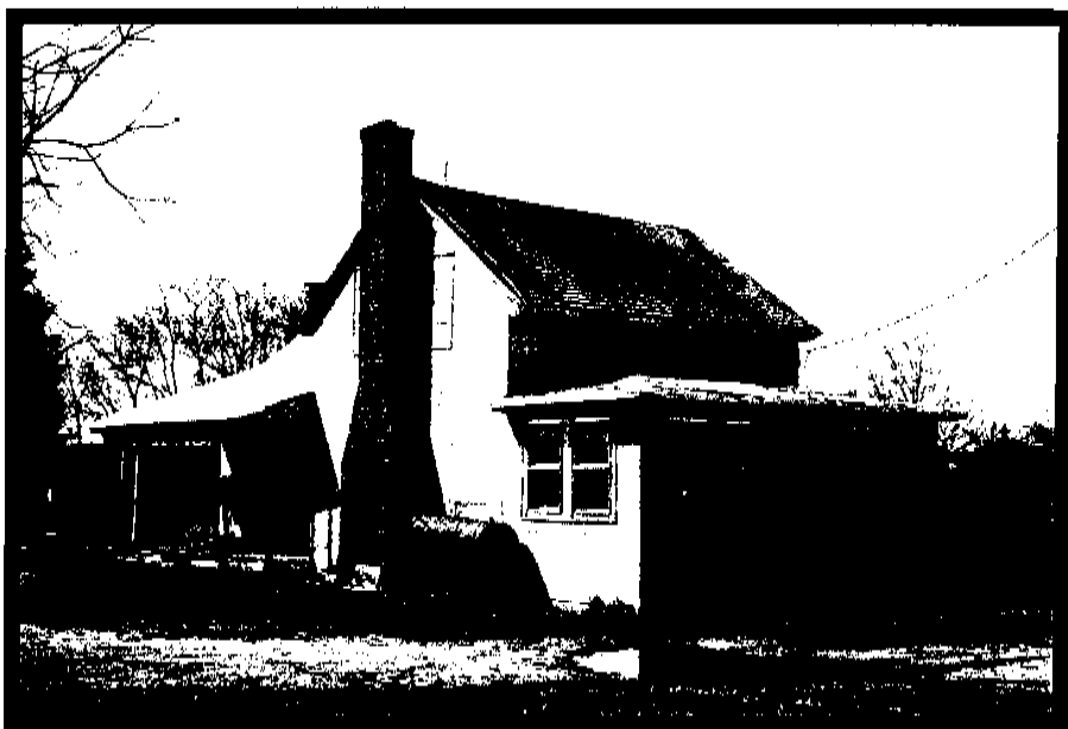
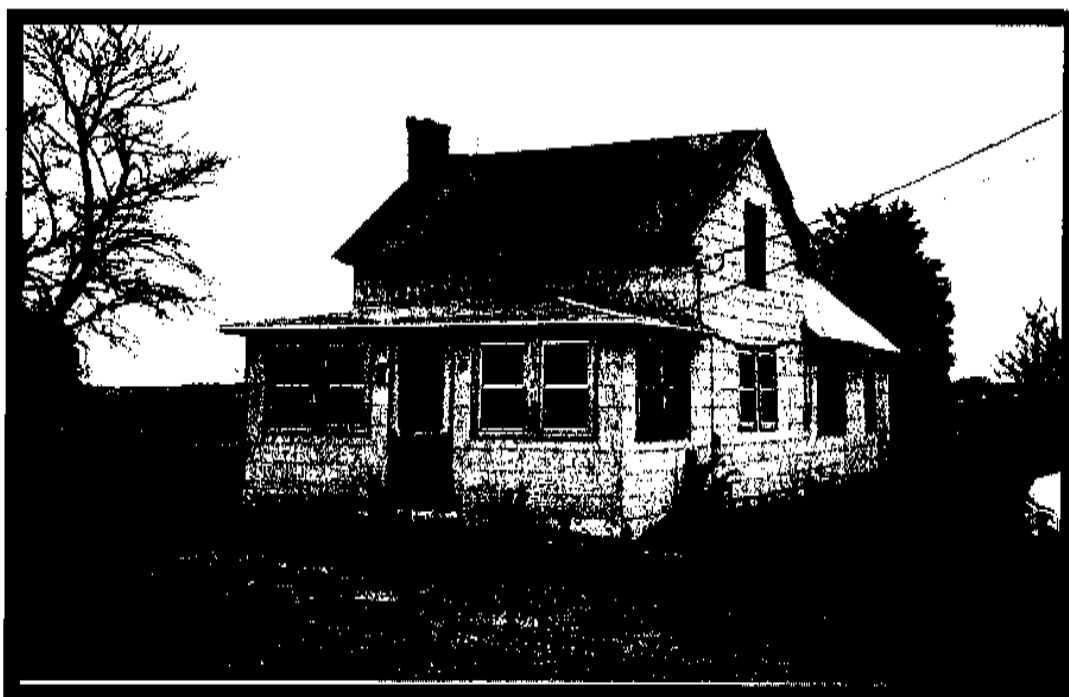
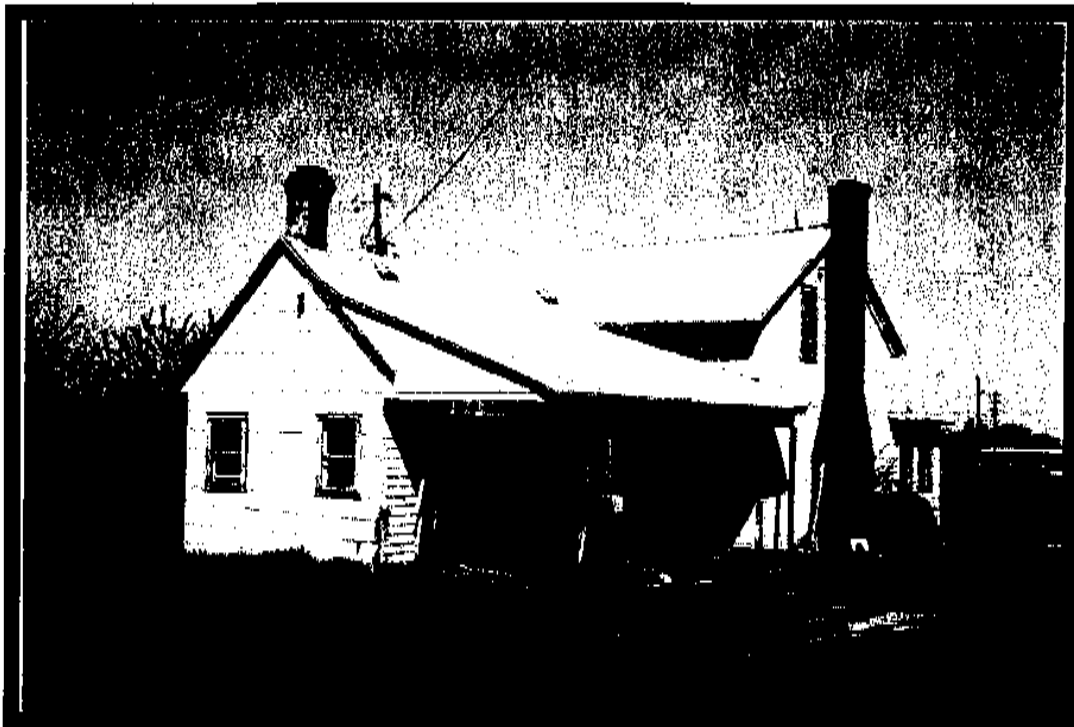
Plate 4.7 T. N. Steel, Jr. House (S-10031), View Southwest of Front and Side Façades.

This property contains a two-story, single-family hall-parlor plan dwelling, built circa 1860, and a barn, chicken house, and garage built in the early twentieth century. The dwelling and the outbuildings are generally in fair-to-poor condition and are located on a 60.99-acre parcel in a semi-rural setting. The historic contexts for this resource are "Architecture in the Lower Peninsula/Cypress Swamp Zone, 1830–1880 +/- and 1880–1940 +/-" and "Agriculture in the Lower Peninsula/Cypress Swamp Zone, 1880–1940 +/-." At the time of the survey, the property was vacant and advertised for sale. The property no longer functioned as a farm and the surrounding fields lay fallow.

The original circa-1860 house is the one-bay, single-pile, two-story section. A one-story addition and porch are attached to the rear, and a full-width enclosed porch is attached to the front. The house is frame construction built on a brick foundation. The exterior walls are finished with asbestos siding over clapboards. The original section and rear addition have gable roofs. The enclosed porch has a hip roof, while the side porch has a shed roof attached to the slope of the addition. All roofs are covered with asphalt shingles. Windows are rectilinear with one-over-one, double-hung, wood sash. Several windows are covered with plywood boards. There is a modern exterior brick chimney on the original section and an original, interior parged chimney on the addition (Plates 4.7–4.9).

This property lacks the necessary physical integrity to be eligible for listing in the NRHP. Key character-defining features have been obscured or replaced, including the original wood siding. Presently, the dwelling is covered with asbestos shingle siding and some window openings are covered with plywood. Additionally, the outbuildings are in poor condition; a former outbuilding lay in ruins during the field survey.

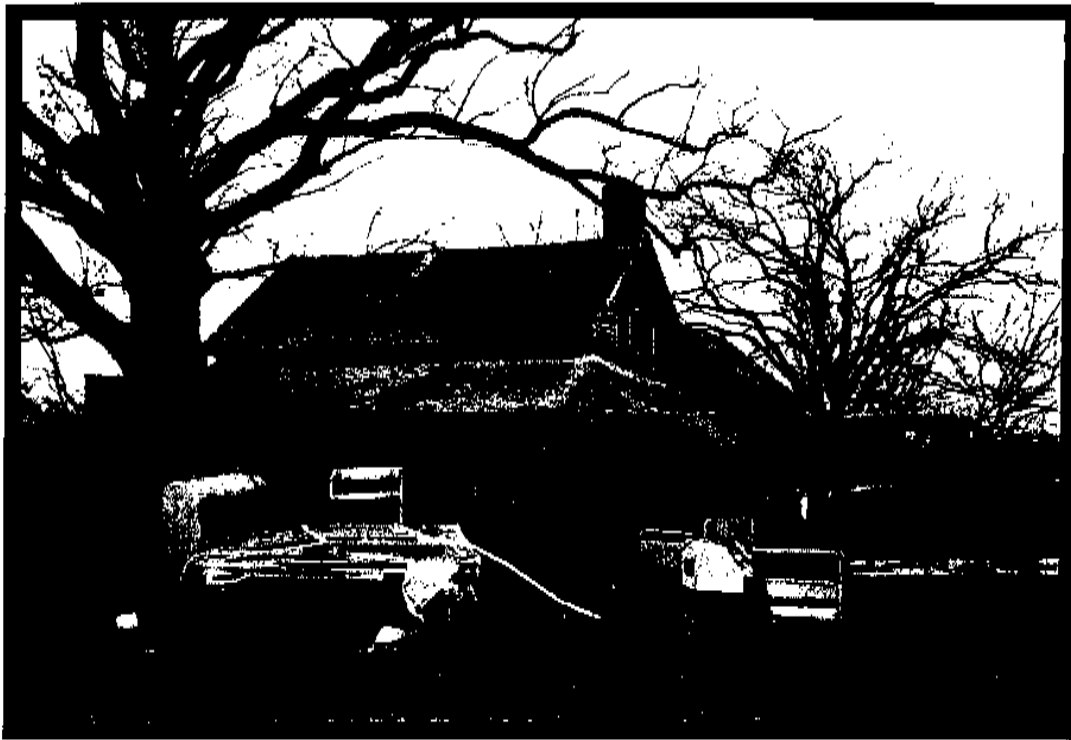
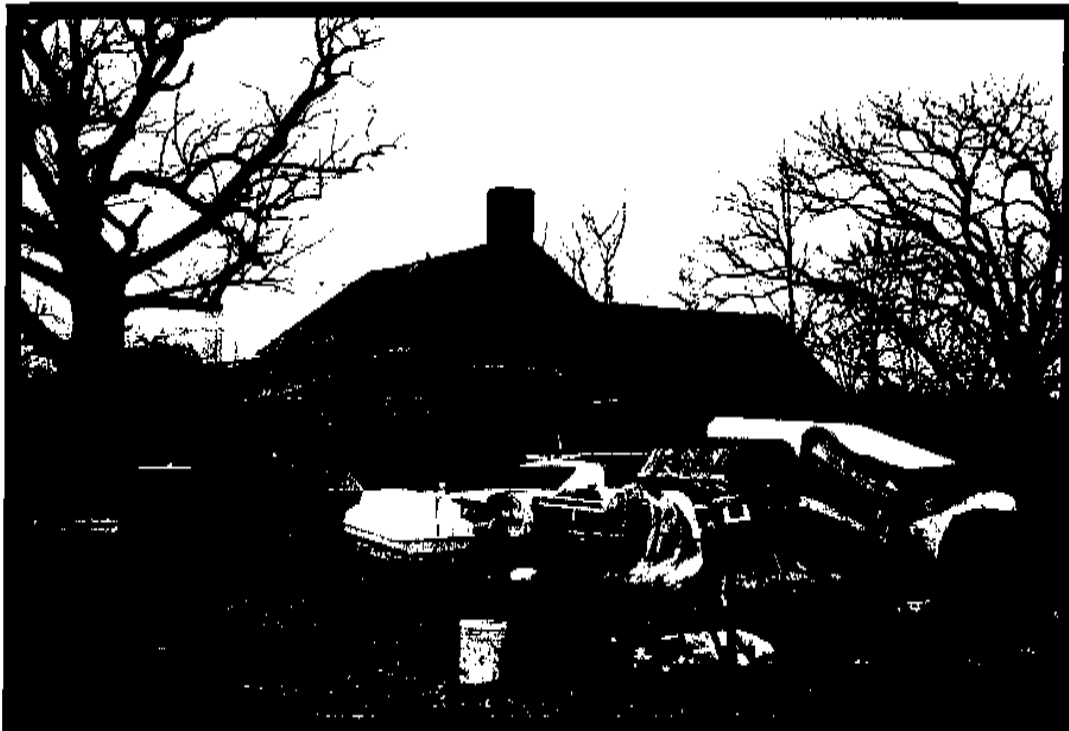
Plate 4.14 Harold Marvel House (S-2454), View North of Front and Side Façades.

This property contains a two-story dwelling built circa 1870 (Plates 4.14 and 4.15). The dwelling is vacant and in poor condition; it is located on the grounds of an auto/truck repair shop and is surrounded by abandoned vehicles. The dwelling is situated on a 7.75-acre parcel within a semi-rural setting. The historic context for this resource is "Architecture in the Lower Peninsula/Cypress Swamp Zone, 1830–1880 +/-." The resource exhibits no association with farming and therefore is not representative of a historic context for agriculture.

The original house is the two-pile, two-story section. Various additions are attached to the front, east, and north/rear elevations. The house is frame construction built on a brick foundation. The exterior walls are finished with clapboards. The gable roof over the main section and rear addition and the hip and shed roofs over the other additions are covered with asphalt shingles. Many windows do not retain sash. Some extant sash includes original two-over-two wood sash on the second floor of the original section and one-over-one wood sash in the additions. The west part of the front addition is an open porch. There is a parged interior chimney on the east gable end of the original house. The house is vacant and in a state of disrepair.

Because its integrity has been compromised, this property lacks important character-defining features of a massed-plan, side-gable house, as defined in the research design. Additions have altered the historic massing and scale of the building. In addition, the resource is in a deteriorated condition, vacant and abandoned, and the integrity of the setting is compromised by a surrounding junkyard. Thus, this property is not considered eligible for listing under Criterion C.

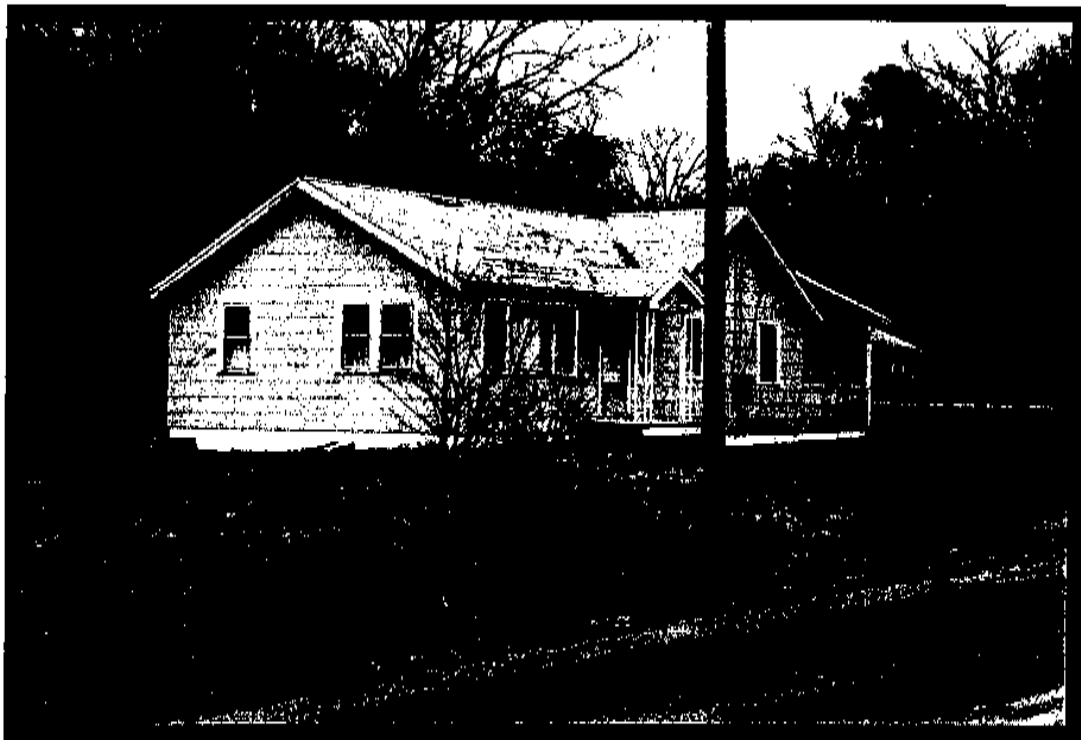
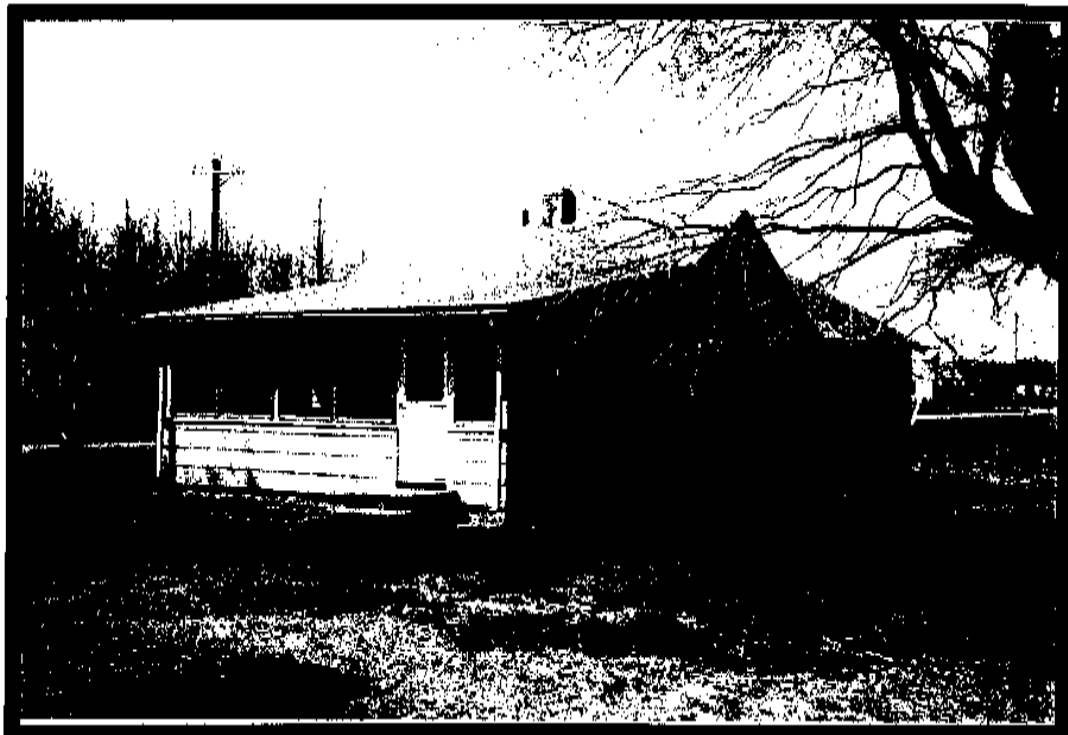
Plate 4.16 Clifton Toomey House (S-2453), View Northeast of Front and Side Façades.

This property contains a single-story dwelling built circa 1950 (Plates 4.16 and 4.17). The dwelling is in good condition and is located close by Burbage Road (Road 353) on a one-acre parcel in a semi-rural setting. The historic context for this resource is "Architecture in the Lower Peninsula/Cypress Swamp Zone, 1940–1960 +/-."

The house is frame construction built on a concrete block foundation. The exterior walls are finished with asbestos siding. The gable roof is covered in asphalt shingles. The windows are rectilinear with original, four-over-one, double-hung wood sash. There is an enclosed porch on the east elevation with one-over-one, double-hung wood sash. A brick chimney projects from the ridge at the cross gable.

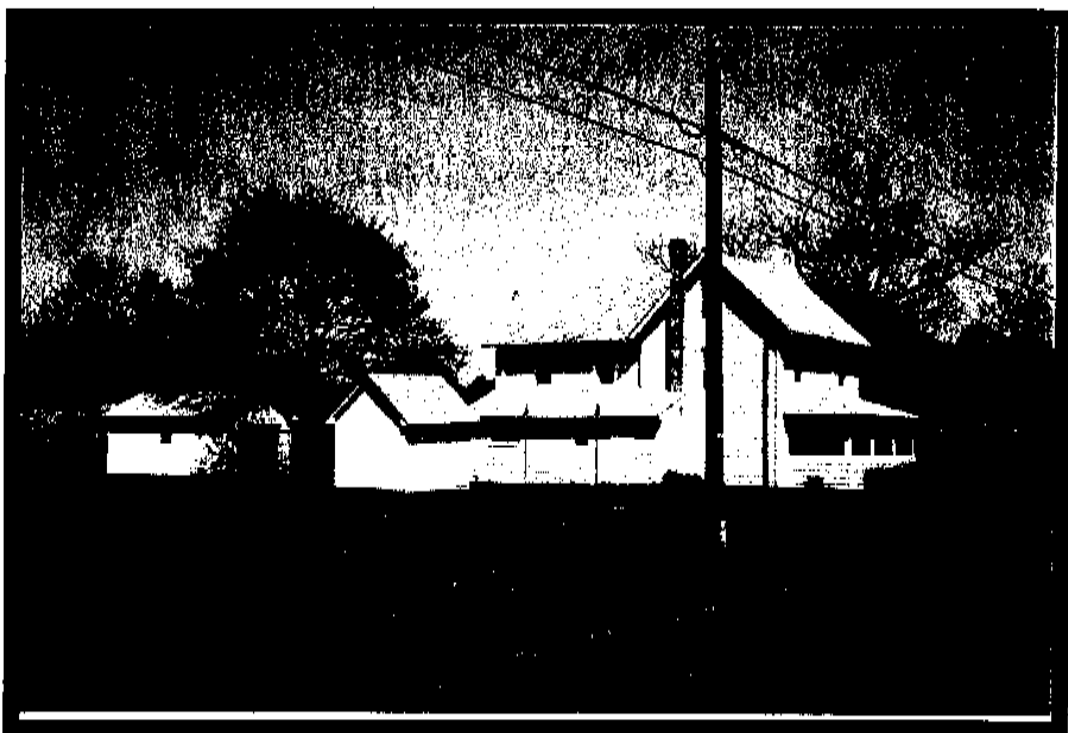
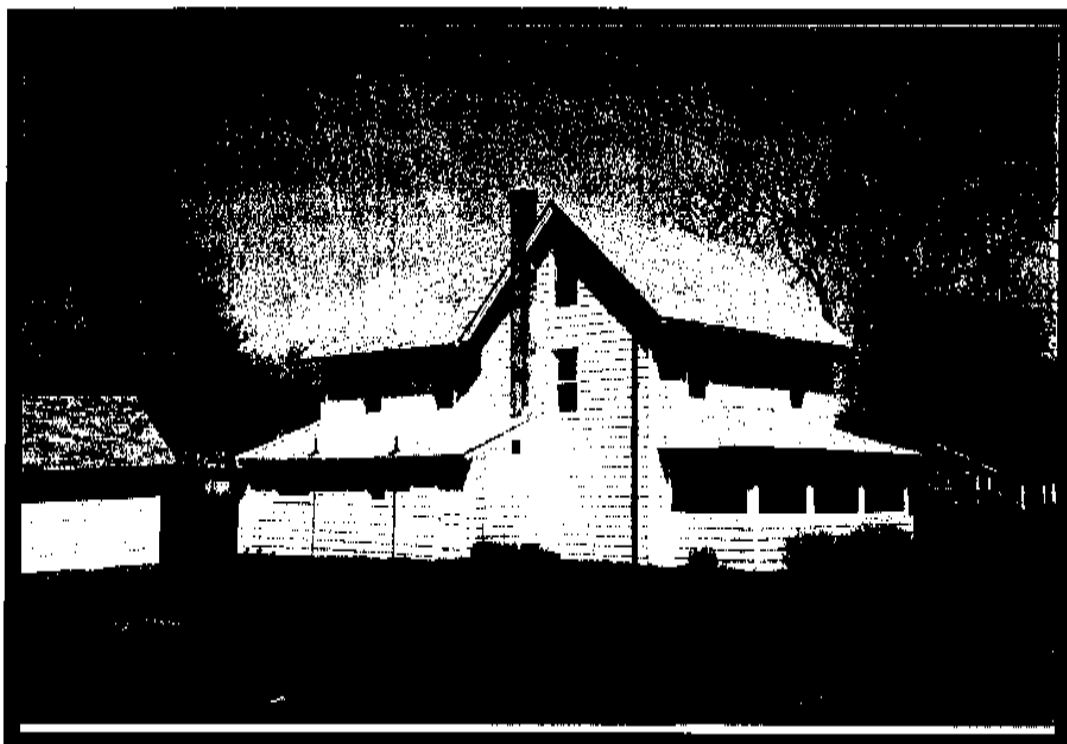
Plate 4.18 Dwelling (S-10032), View North of Property from Windmill Road (Road 352).

This property contains a two-and-one-half-story, single-family dwelling built circa 1875, a shed built circa 1920, and a garage built in the first half of the twentieth century (Plates 4.18 and 4.19). The dwelling is in good condition and is located on a 1.73-acre parcel in a suburban setting. The historic context for this resource is "Architecture in the Lower Peninsula/Cypress Swamp Zone, 1830–1880 +/-." The resource exhibits no association with farming and therefore is not representative of a historic context for agriculture.

The original dwelling is a two-bay, two-pile massed-plan side-gable house. The two-and-one-half-story addition to the rear forming the T-shaped plan may be original or an early addition. Twentieth-century one-story additions are attached to the north and south elevations of the two-and-one-half-story rear section. The house is frame construction on a concrete block crawlspace. The exterior walls are finished with aluminum siding. The roofs are gable and shed configurations covered with asphalt shingles. Windows are rectilinear with replacement, one-over-one, double-hung vinyl sash—except for the south attic window, which retains original, two-over-two, double-hung wood sash. A screen porch spans the front elevation. An exterior, modern concrete block flue is attached to the south gable-end of the original section. The shed is frame construction with a parged foundation, aluminum siding, and a gable roof covered with asphalt shingles. The garage is frame construction with aluminum siding, two six-light fixed sash, and a front gable roof covered with asphalt shingles.

This property lacks the necessary physical integrity to be eligible for listing in the NRHP. Key character-defining features have been obscured or replaced, including the original wood siding and wood windows. Additionally, large additions to the front and rear façades have interrupted the historic massing and scale of the resource.

Because its integrity has been compromised, this property lacks important character-defining features of a massed-plan, side-gable house, as defined in the research design. The building's original wood siding and windows have been replaced by vinyl siding and vinyl windows, respectively. The use of wood is defined as an important, character-defining feature in this property type. In addition, the building's original massing has been compromised by shed-roof additions to the rear and side façades. As such, this building lacks critical character-defining features associated with its property type. Thus, this property is not considered eligible for listing under Criterion C.

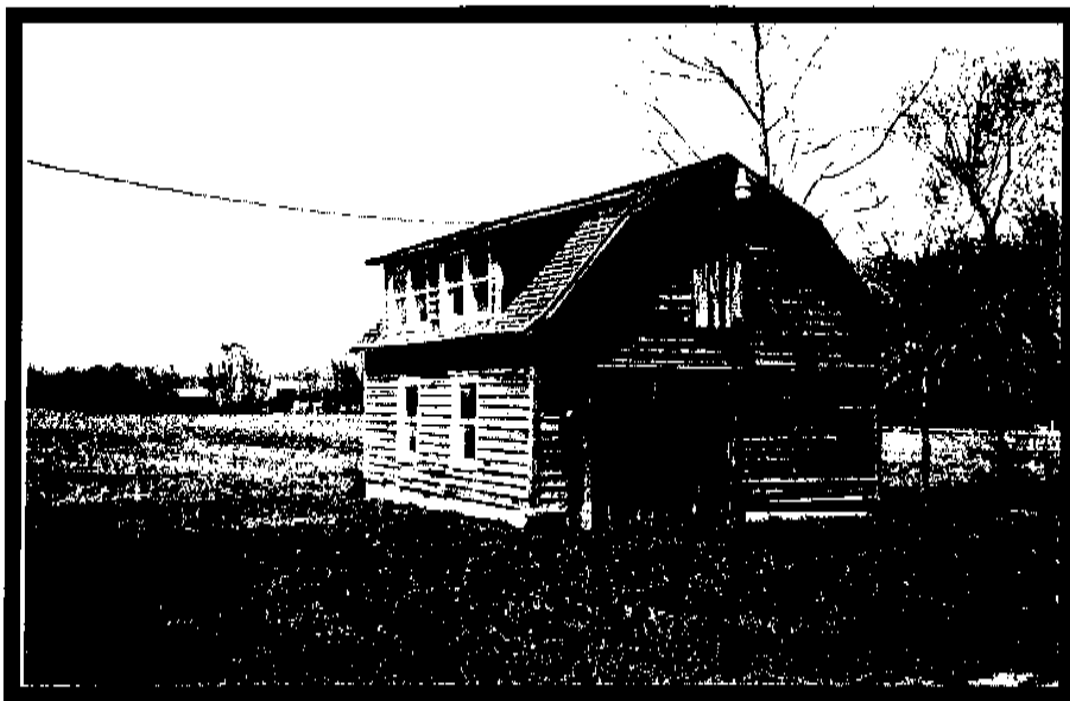
Plate 4.20 J. Hall House (S-2356), View South of Property from Windmill Road (Road 352).

This property contains a two-story dwelling built circa 1850 and an early-twentieth-century barn (Plates 4.20-4.23). The dwelling is in good condition and is located on a 1.67-acre parcel in a semi-rural setting. The historic context for this resource is "Architecture in the Lower Peninsula/Cypress Swamp Zone, 1830–1880 +/-." The resource exhibits no association with farming and therefore is not representative of a historic context for agriculture.

The original house is the central, two-and-one-half-story section. It is obscured by a one-and-one-half-story addition on the rear, a two-story addition on the north, and a double-height addition on the front/east. There is also a small, one-story addition on the rear of the one-and-one-half-story addition. The house is frame construction. The original foundation is not visible, but additions are built on concrete block foundations. The exterior walls are finished with asbestos siding. The gable roofs are covered with asphalt shingles. None of the original windows are visible. Windows on the additions have double-hung, sliding, and fixed sash. The barn is frame construction with a modern concrete block foundation, clapboard walls, and a gambrel roof covered with wood shingles. The barn has been modified with a shed roof dormer and non-original window openings in the barn wall and dormer.

This property lacks the necessary physical integrity to be eligible for listing in the NRHP. Key character-defining features have been obscured or replaced, including the original wood siding and wood windows. Additionally, large additions to the front, rear, and side façades have interrupted the historic massing and scale of the resource.

Because its integrity has been compromised, this property lacks important character-defining features of an example of nineteenth-century folk housing, as defined in the research design. The building's original massing has been compromised by numerous additions to the front, rear, and side façades. Original window openings have been closed and covered with siding. As such, this building lacks critical character-defining features associated with its property type. In addition, the small barn on the property no longer retains integrity due to non-original dormer

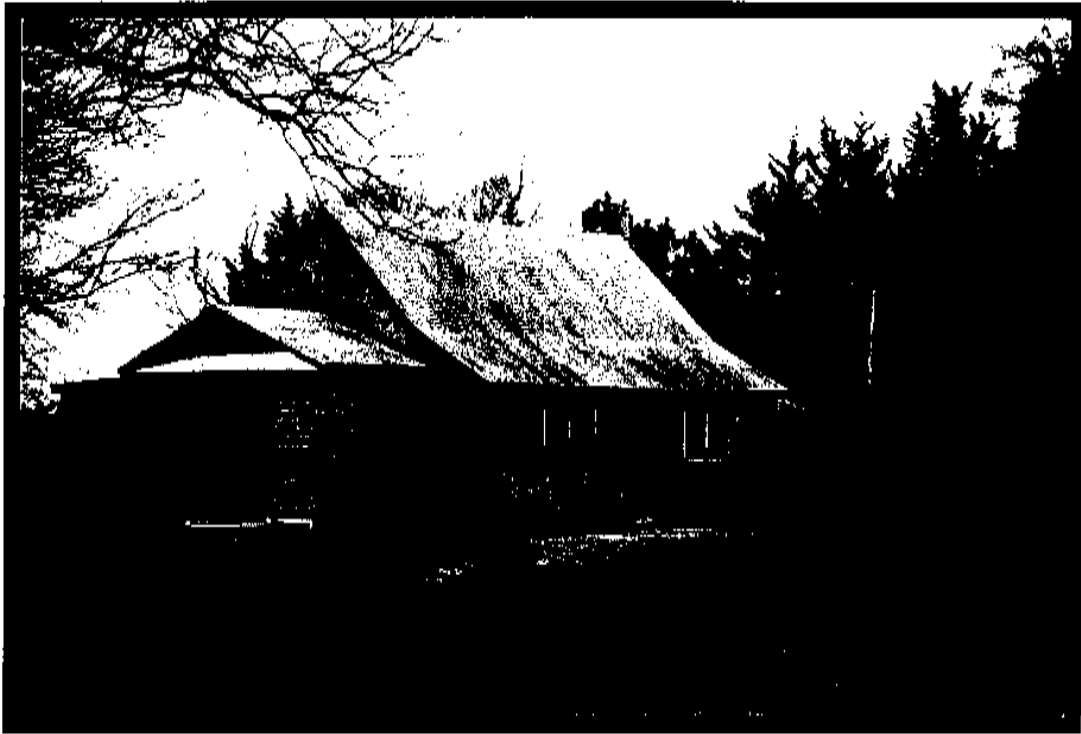
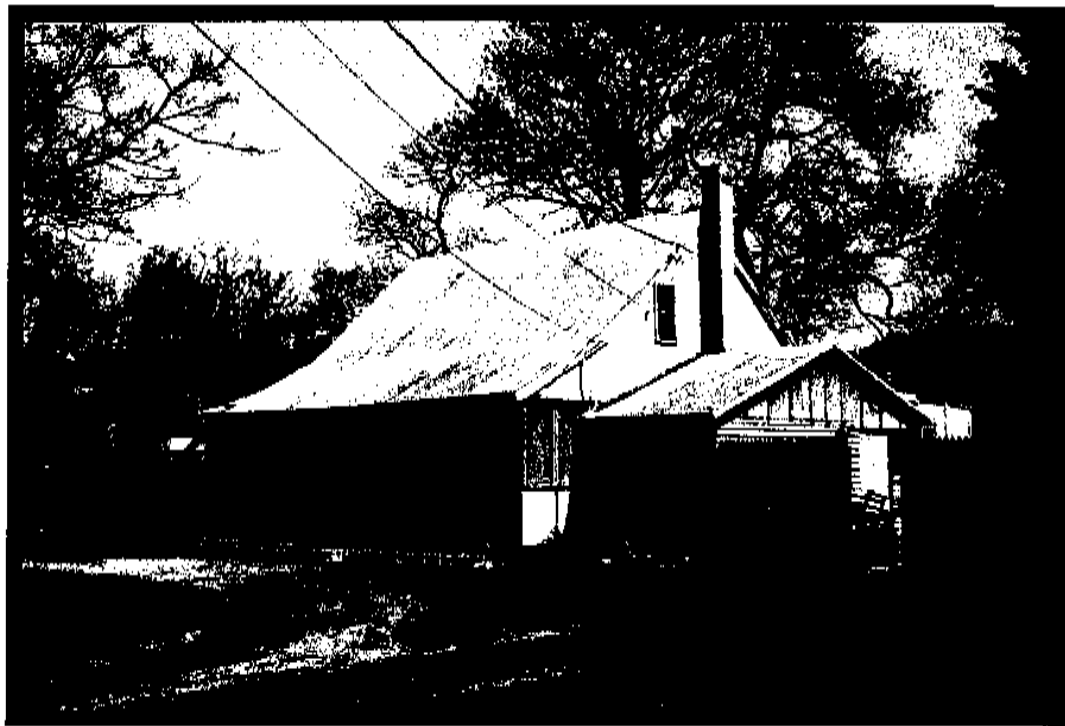
Plate 4.24 Orville Quillen House (S-10033), View Southeast of Front and Side Façades.

This property contains a one-and-one-half-story dwelling built circa 1945 and a modern storage building (Plates 4.24 and 4.25). The dwelling is in good condition and is located on a 0.56-acre parcel in a semi-rural setting. The historic context for this resource is "Architecture in the Lower Peninsula/Cypress Swamp Zone, 1940–1960 +/-."

Visual inspection does not indicate the Orville Quillen House is significant for its distinctive characteristics or method of construction. This resource is a mid-twentieth-century vernacular bungalow that lacks the hallmarks of a high-style, architect-designed, or even mail-order, version of the type. As noted in the research design, this resource lacks the "low-sloping roof that sweeps over a verandah" as well as the "interpenetration of inner and outer space" that Gowans identified as defining characteristics of the bungalow. Similarly, regarding Herman's findings on "rural bungalows," this resource lacks the "low-pitched roof that terminates in deep, overhanging eaves" and the "deep porch... anchored by pillars at the corners." Lastly, the enclosed porch, consisting of plywood and screening, has compromised the property's integrity of design. As a result, this property is not considered eligible for listing under Criterion C.

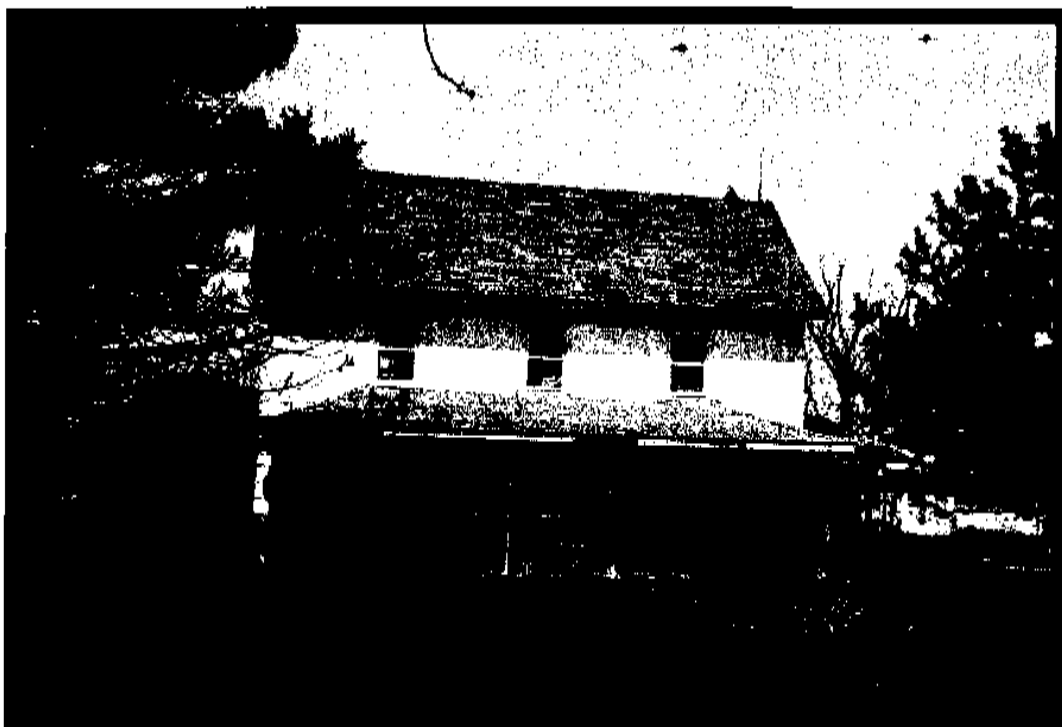
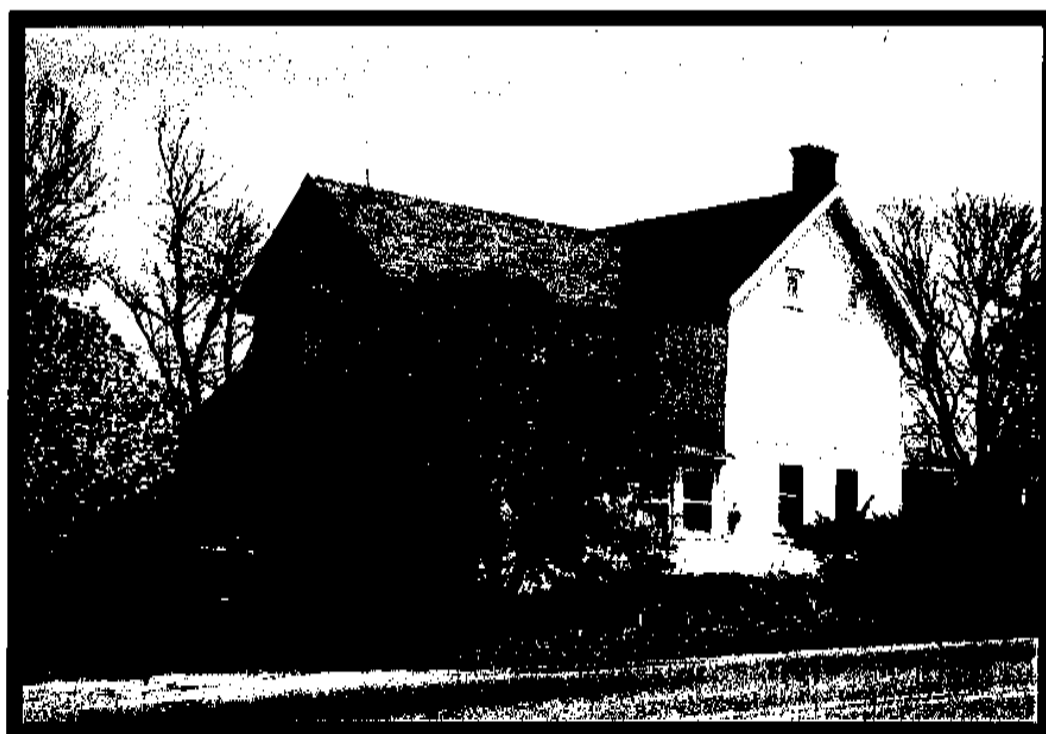
Plate 4.26 A. Clark House (S-2342), View West of Front Façade.

This property contains a two-and-one-half-story dwelling built circa 1860, a modern shed, and a modern shower structure (Plates 4.26 and 4.27). The dwelling is in good condition and is located on a 1.01-acre parcel in a semi-rural setting. A new golf course community, Bear Trap Dunes, is being developed across Central Avenue (Road 84) from this resource. The historic context for this resource is "Architecture in the Lower Peninsula/Cypress Swamp Zone, 1830–1880 +/-." The resource exhibits no association with farming and therefore is not representative of a historic context for agriculture.

The original dwelling is the three-bay, single-pile I-house. The two-and-one-half-story section to the rear forming the T-shaped plan may be original or an early addition. Early twentieth-century one-story additions are attached to the rear extension. The house is frame construction built on a brick foundation. The exterior walls are finished with asbestos siding. There are gable roofs over the two-and-one-half-story sections and shed roofs over the one-story sections. All roofs are covered with asphalt shingles. The windows on the first and second floors are rectilinear with two-over-two and one-over-one, double-hung wood sash. Attic windows have four-light, wood casement sash and jalousie sash. There is a full-width screen porch on the front elevation and a large open porch on the north elevation. Chimneys include an original, interior brick chimney at the south gable-end and a modern, exterior brick flue on the north elevation. The shed and outdoor shower are frame construction with asphalt shingle roofs.

Because its integrity has been compromised, this property lacks important character-defining features of an I-house, as defined in the research design. The use of wood is defined as an important, character-defining feature in this property type. The building's original wood siding has been replaced with or obscured by asbestos shingle siding. Also, the front porch and side deck/patio introduce modern materials and designs that are incongruous with a nineteenth-century I-house and detract from its integrity. As such, this building lacks critical character-defining features associated with its property type. Thus, this property is not considered eligible for listing under Criterion C.

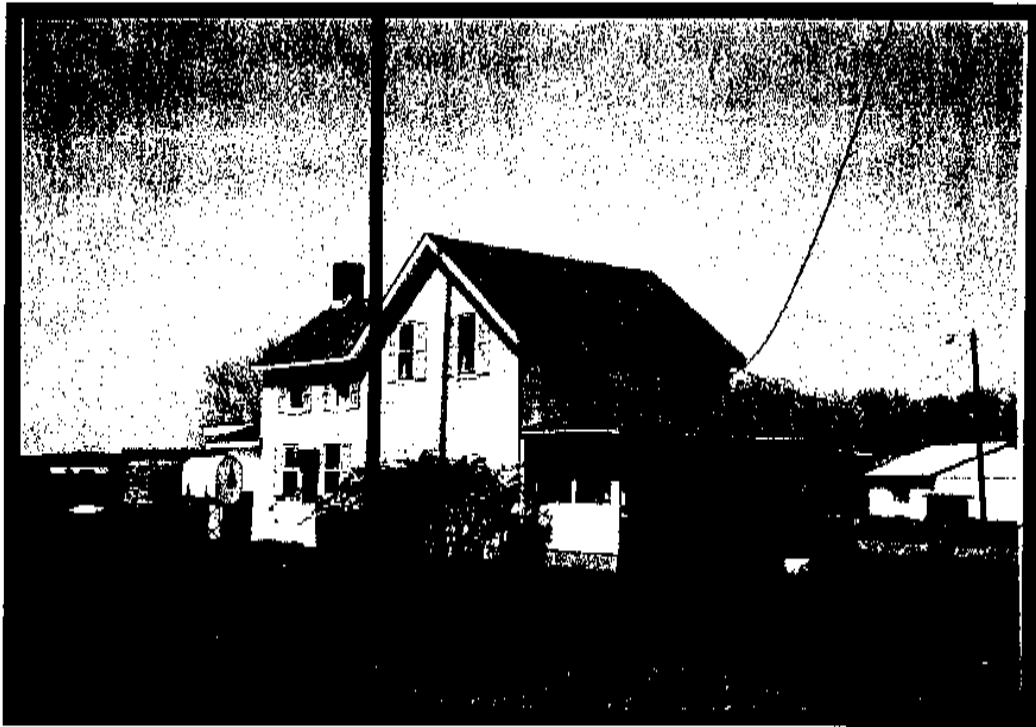
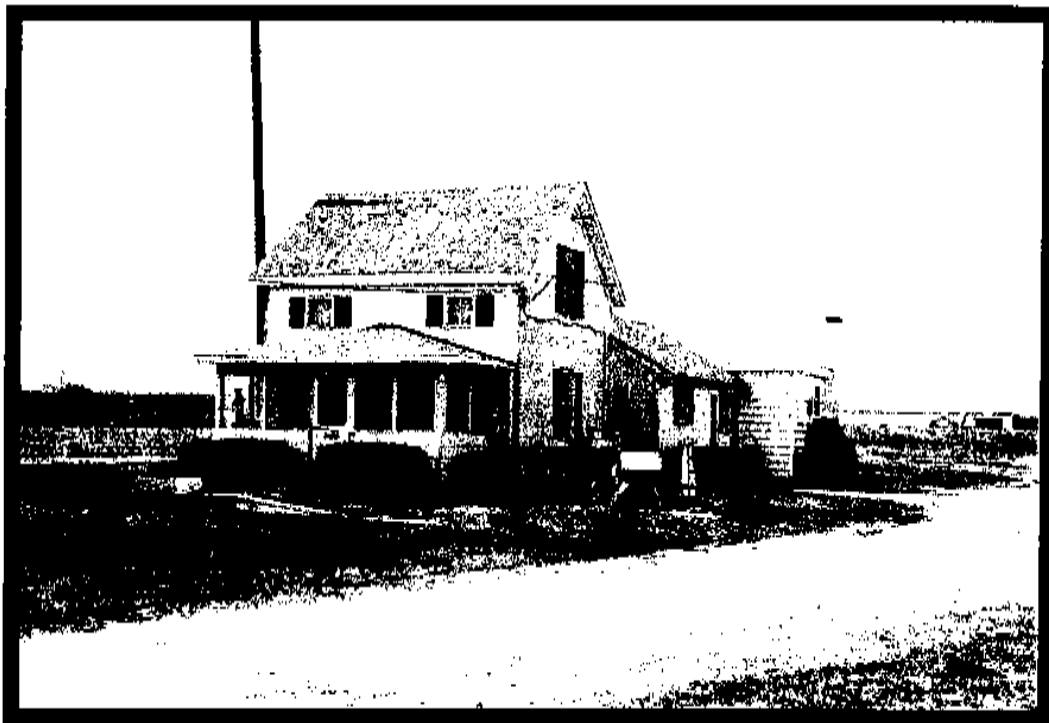
Plate 4.28 E. Chandler House (S-2355), View North of Front and Side
Façades.

This property contains a two-story, single-family dwelling built circa 1860, three chicken houses built circa 1940, a masonry storage building built circa 1950, an open garage built in the third quarter of the twentieth century, and a modern shed (Plates 4.28–4.31). The dwelling is in good condition and is located on a 34.87-acre parcel in a semi-rural setting. Bear Trap Dunes, a golf course community, is currently being developed on the opposite side of Central Avenue (Road 84). The historic contexts for this resource are “Architecture in the Lower Peninsula/Cypress Swamp Zone, 1830–1880 +/-” and “Agriculture in the Lower Peninsula/Cypress Swamp Zone, 1830–1880 +/-.”

The original house is the L-plan, two-story section. Modern additions include a one-story, gable-roofed section and a one-story, flat-roofed section. The house is frame construction on a concrete block foundation. The exterior walls are finished with aluminum siding. The gable roofs are covered with asphalt shingles. Windows are rectilinear with replacement, double-hung sash. There is an enclosed porch on the front elevation with aluminum siding base walls and jalousie windows. An interior brick chimney projects from the ridge of the rear gable end, and a modern concrete block, exterior flue is attached to the flat-roofed addition. The smaller chicken house is frame construction with horizontal board siding, exposed rafter ends, and a shed roof. The two large chicken houses are frame construction with sheeting over clapboard walls and gable and shed roofs covered with standing seam metal. The storage building is painted concrete block construction with a gable roof covered with metal siding. The cart shed is built of telephone poles and has a shallow-sloped shed roof. The modern storage shed is frame construction with T-111 walls and a gambrel roof covered with asphalt shingles.

This property lacks the necessary physical integrity to be eligible for listing in the NRHP. Key character-defining features have been obscured or replaced, including the original wood siding and wood windows. Additionally, additions to the rear and side façades have interrupted the historic massing and scale of the resource.

Because its integrity has been compromised, this farmhouse lacks important character-defining features of a massed-plan, side-gable house, as defined in the research design. The building's original wood siding and windows have been replaced by aluminum siding and replacement windows, respectively. The use of wood is defined as an important, character-defining feature in this property type. In addition, the building's original massing has been compromised by additions. As such, this building lacks critical character-defining features associated with its property type. The chicken houses on this property are in poor condition, vacant, and unused. There is no indication the chicken houses are significant for their design or construction. Thus, this property is not considered eligible for listing under Criterion C.
